#19-NA-235: Rattle or Ticking Noise from B-Pillar Area - (Oct 15, 2019)

Subject: Rattle or Ticking Noise from B-Pillar Area.

Brand:	Model:	Model Year:		VIN:		Engine:	Transmission:
		from	to	from	to		
Chevrolet	Equinox	2019	2020			All	All
GMC	Terrain

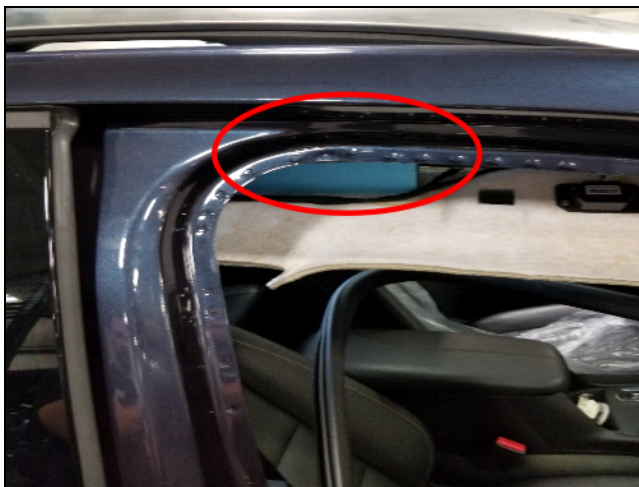
3. Locate the sheet metal area at the rear radius, shown in the graphic above.

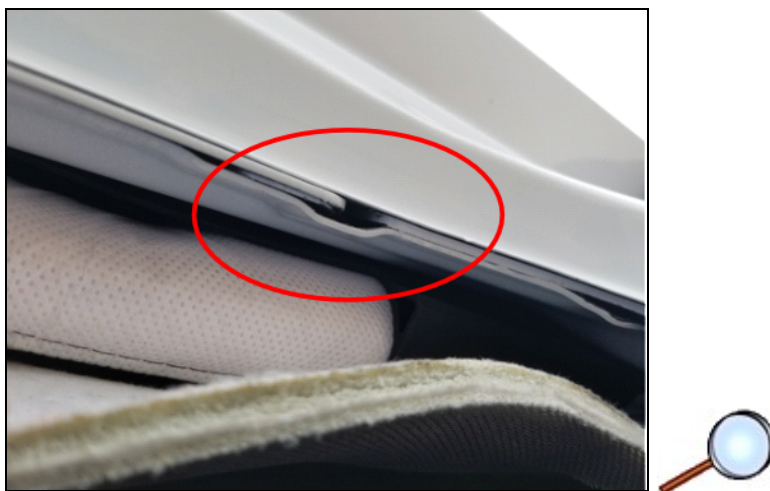
4. Locate the crease/gap in the sheet metal.

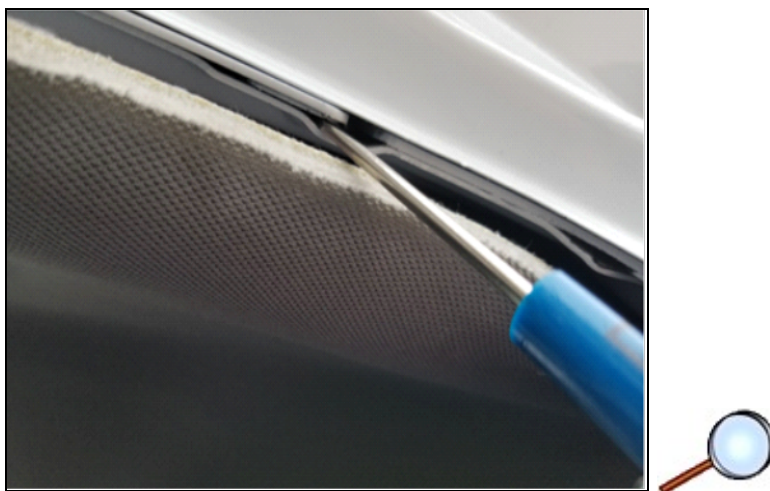
5. As shown in the graphic above, carefully insert a screwdriver into the crease and wiggle it back and forth.

- If the noise is NOT eliminated, DO NOT complete the repair below, but continue with further SI diagnostics to pinpoint the cause.
- If the noise IS eliminated, continue on to step #6 and complete this repair.
