Transmission Control Modules

Applications

Programming and Installation

TCM/TEHCM SERVICE GUIDE

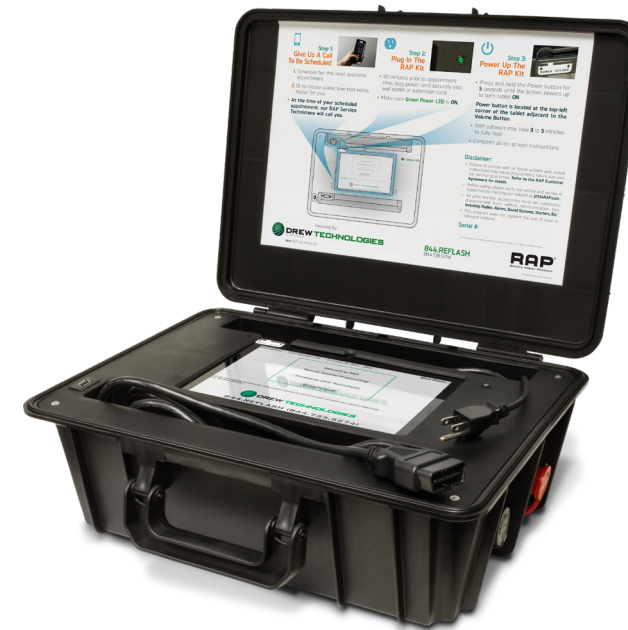
DORMAN REMOTE ASSIST PROGRAMMING / BY DREW-TECH

STEP 1: Please call Drew Technologies Customer Service at 844-REFLASH (844-733-5274) to schedule the programming session. This may take several hours depending on workload and demand. Please be sure to attach jumper cables from the vehicles 12 V battery to the corresponding positive and negative ports on the side of the RAP tool.

STEP 2: When contacted, plug the 110 V service plug into a power outlet and plug the OBD-II adapter into the diagnostic service port.
